# Quench Incident Action

## 35,000L TANKER EXPLOSION- Wyong

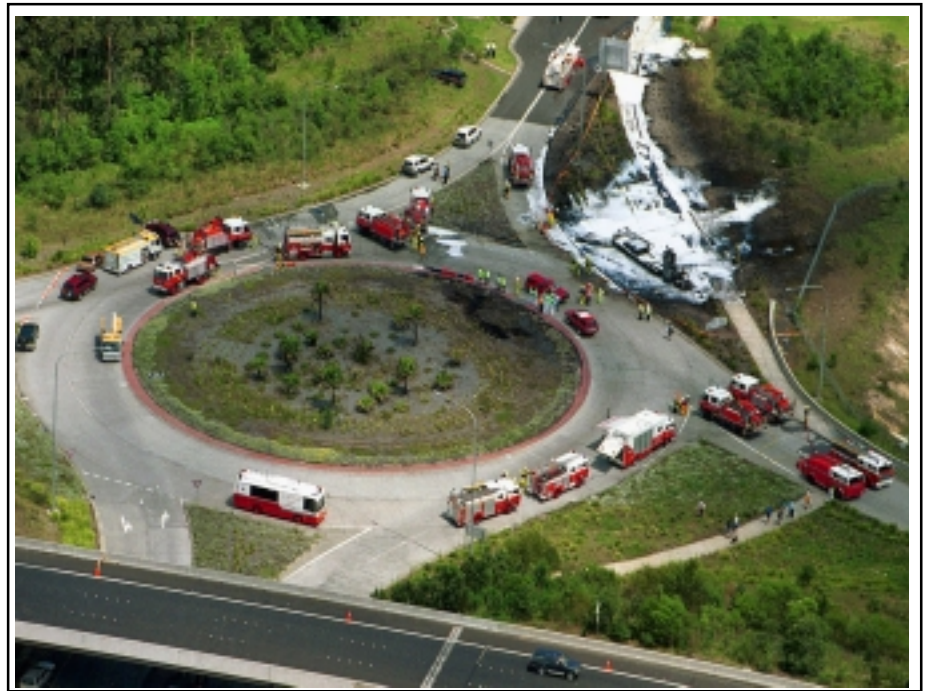
*Aerial View of the crash scene after the fire had been extinguished*

fuel was also alight and had scorched a lot of the plant life as well as the public toilet block for the rest area.

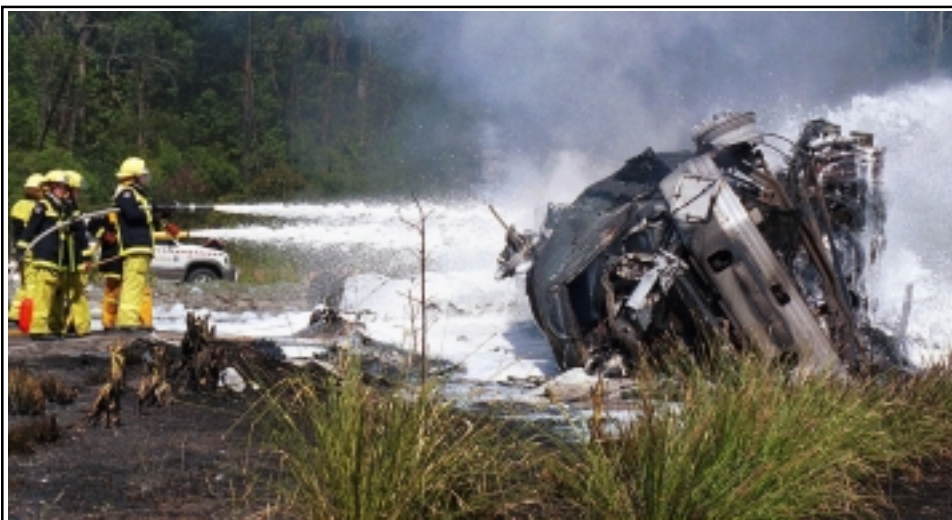
*RFS and NSWFB crews working together on maintaining the foam blanket*
